# Real-Time 3D Transesophageal Echocardiographic Guidance of Prosthetic Valve Paravalvular Leak

Joseph M. Venturini MD, Anuj Mediratta MD, Karima Addetia MD, Sandeep Nathan MD, Atman P. Shah MD, Roberto M. Lang MD\*

University of Chicago Medical Center, Section of Cardiology, Chicago, Illinois, USA

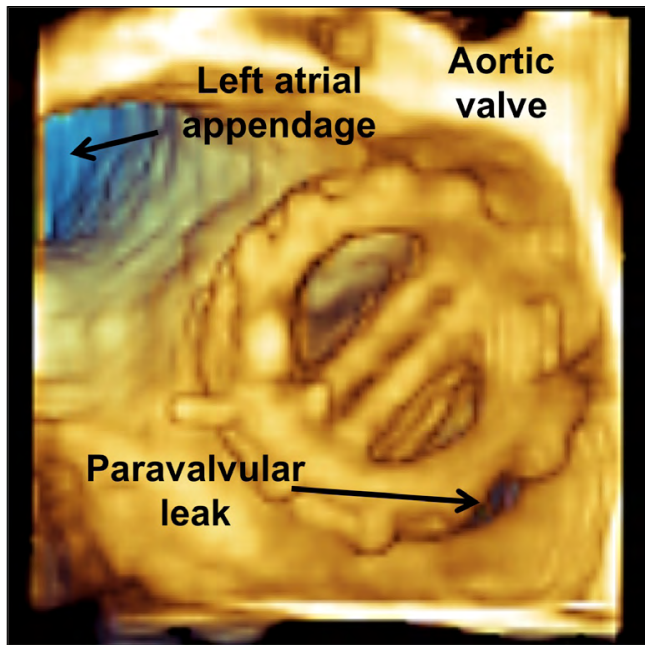
**Figure 2.** 3D zoom view of the mechanical mitral prosthesis with paravalvular leak as noted. Aortic valve is in the 12 o'clock position.

Due to location of the defect ([Figure 2](#), [Video 3](#)) and the presence of a mechanical aortic valve, a trans-apical approach was chosen for percutaneous closure over a trans-septal or retrograde aortic approach. After apical access was obtained, the paravalvular defect was identified and crossed with a 0.035inch x 150 cm Terumo straight stiff glide wire (Terumo Medical, Somerset, New Jersey, USA) ([Figure 3](#)) with 3DTEE guidance. Initially, an 8-mm muscular ventricular septal defect occluder (St. Jude Medical, St. Paul, Minnesota, USA) was positioned and deployed into the large defect. On 3DTEE and fluoroscopy, there was evidence of entrapment of a mechanical mitral valve leaflet and the device was retrieved. Next, a

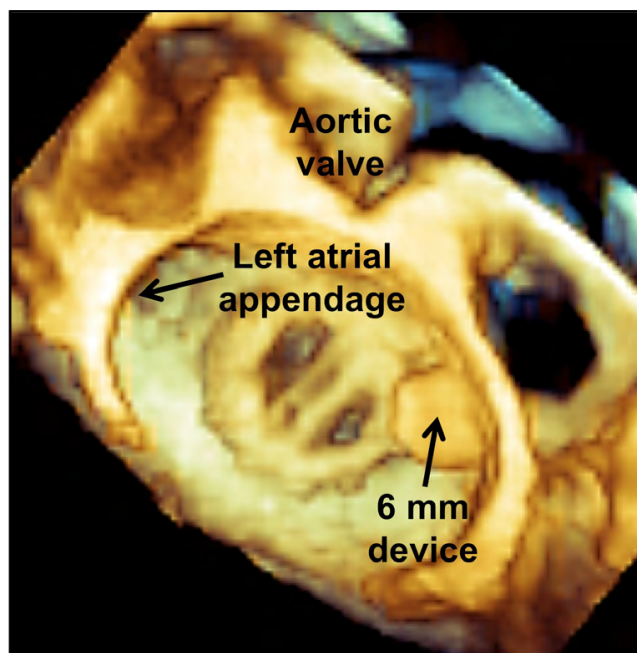
**Figure 4.** 3D full-volume rendering of the mechanical mitral prosthesis with 6-mm occluder device in position. Aortic valve is in the 12 o'clock position.

6mm muscular VSD occluder device (St. Jude Medical, St. Paul, Minnesota, USA) was placed into the defect without compromise of leaflet mobility on TEE ([Figure 4](#), [Video 4](#)) and fluoroscopy. TEE confirmed closure of the large PVL. Using transthoracic echocardiographic guidance, the trans-apical puncture site was closed with a 6mm/4mm Amplatzer Duct Occluder (St. Jude Medical, St. Paul, Minnesota, USA). The patient tolerated the procedure well and was discharged home 3 days later.

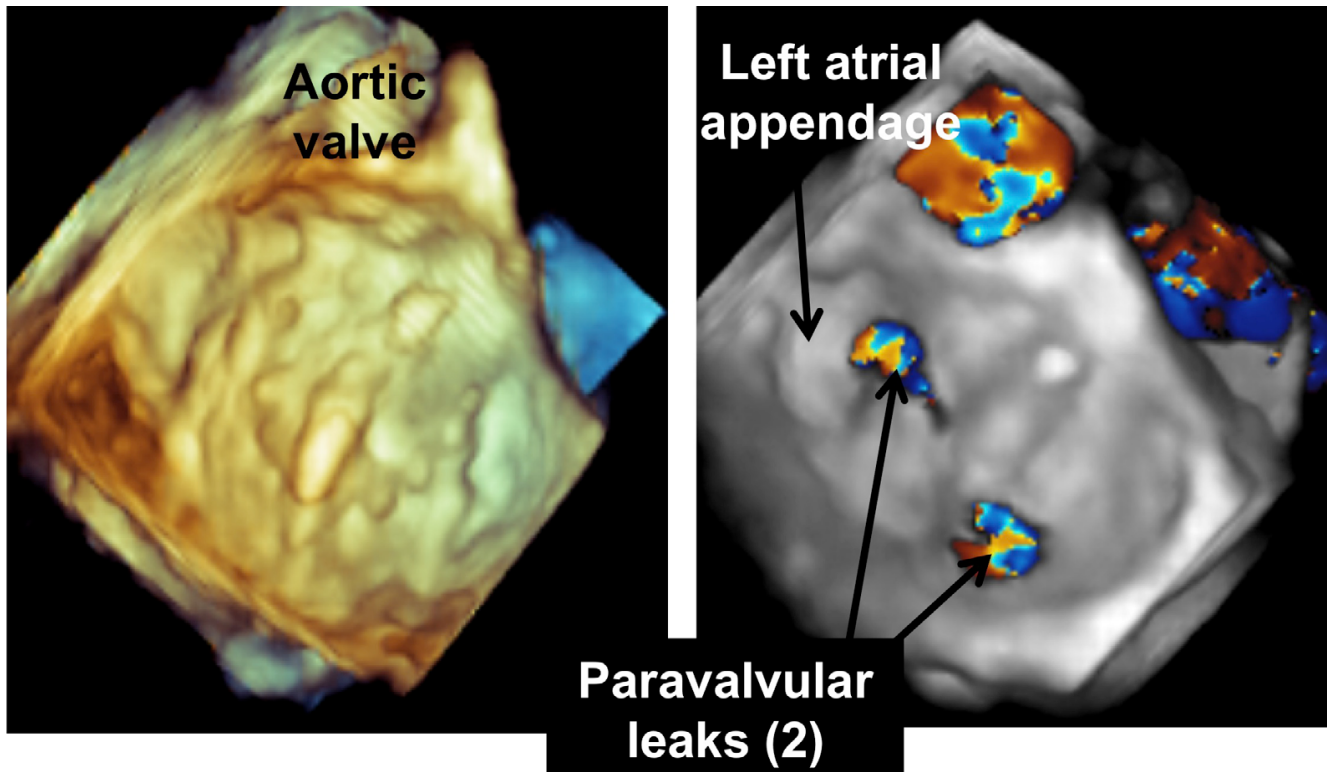
**Figure 5.** 3D zoomed rendering of the mechanical mitral prosthesis (left panel). With this modality, it is difficult to appreciate the two disks associated with the valve prosthesis in this patient. The paravalvular leaks are not seen. The 3D color zoom acquisition of the mitral prosthesis allows better appreciation of the location and number of paravalvular leaks (right panel). This patient has two paravalvular leaks. Aortic valve is in the 12 o'clock position.

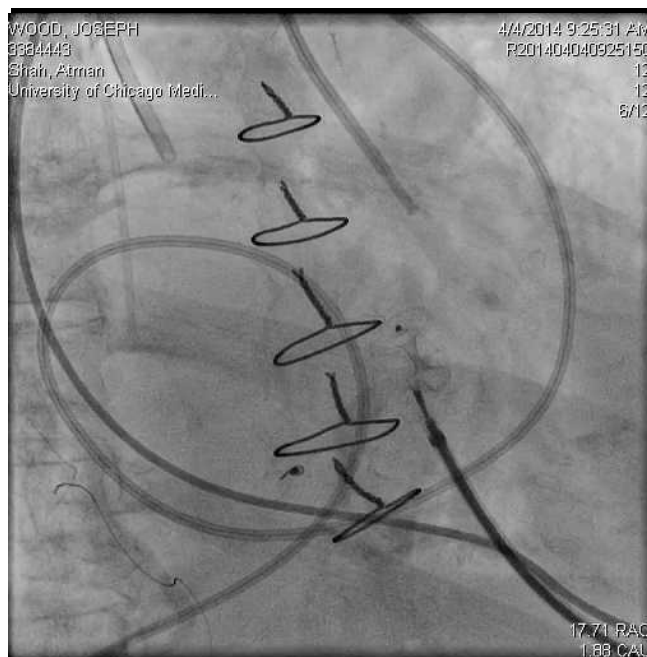
**Video 5.** Case 2: Fluoroscopy showing evidence of entrapment of the posterior mechanical mitral valve leaflet.

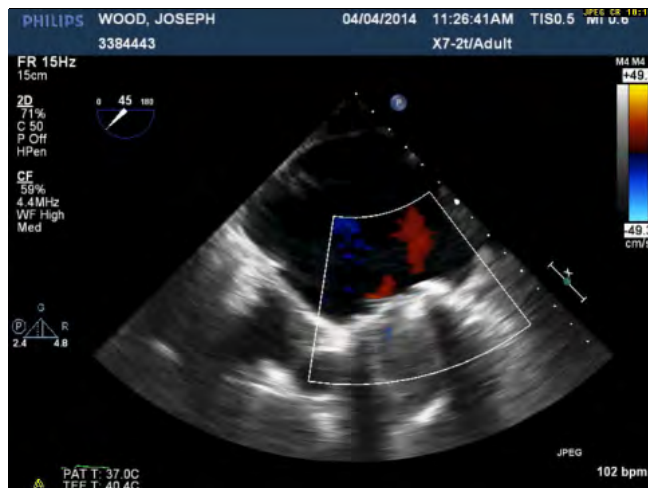
**Video 7.** Case 2: 2D color Doppler TEE showing evidence of entrapment of the posterior mechanical mitral valve leaflet.
